MONTHLY WEATHER REVIEW

A SEQUENCE OF TORNADO DAMAGE PATTERNS

Ferguson Hall and Robert D. Brewer

An investigation is made of the patterns of damage associated with a series of tornadoes in west-central Wisconsin on June 4, 1958. Three flow models are presented to account for the different patterns exhibited in different portions of the paths.

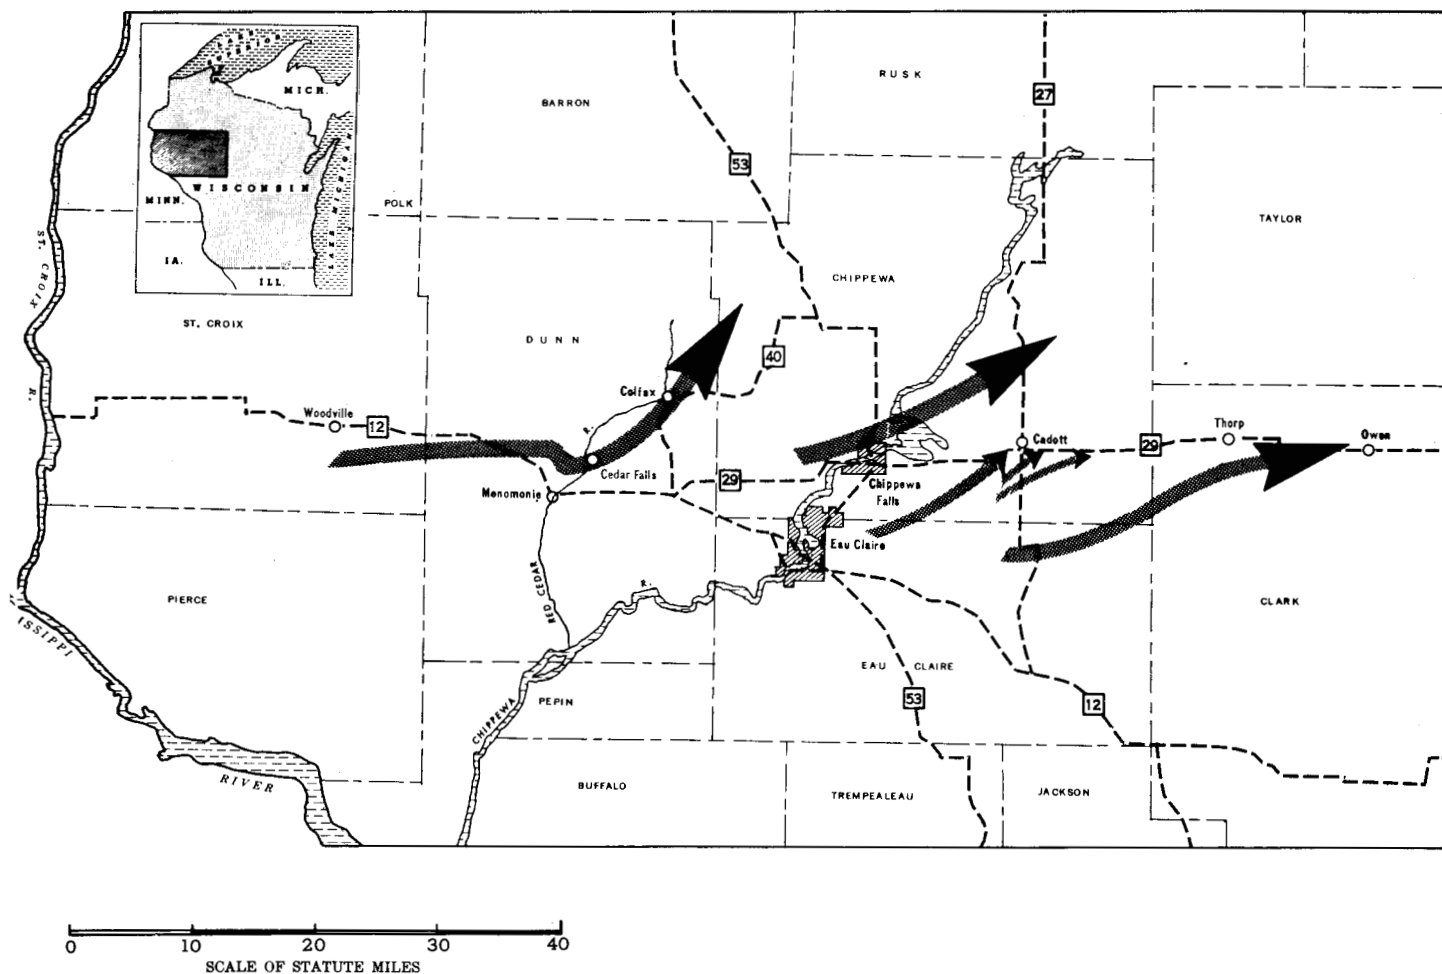
FIGURE 1.—Paths of major tornadoes of storm system.

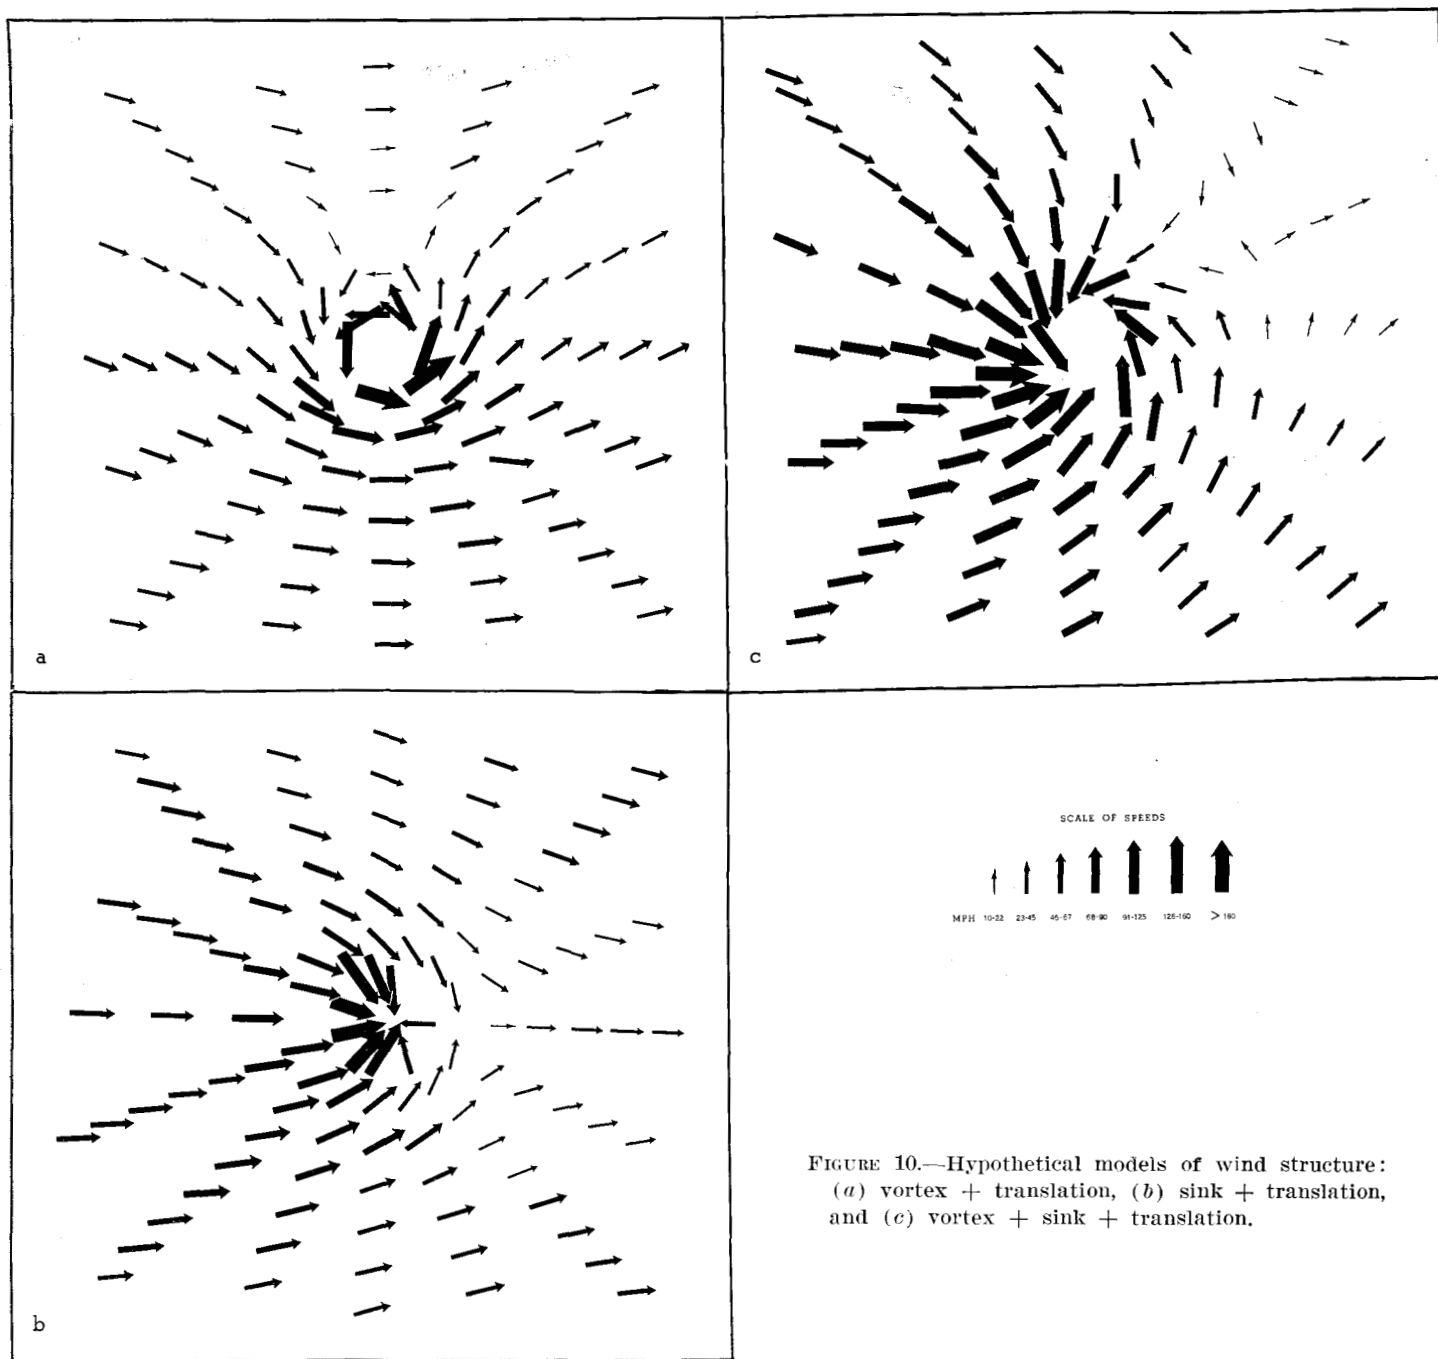
in figure 10. Model (a) would undoubtedly account for the patterns of both figure 3 and figure 6, where rotation and translation seem predominant and the degree of "circularity" of the pattern would depend upon the forward speed of the system relative to the intensity of the vortex circulation. Thus the strongly circular patterns at the beginning of figure 3, where the tornado first touched ground, and at point "A" of figure 6 imply high vortex speeds or low forward motion. In the first case it seems possible that the funnel may have built up to very high speed just before touching the ground. Then due to surface friction this speed may have been reduced to give the translational type of pattern immediately following and continuing for the next mile or two. In the case of the circular patterns of figure 6, a marked deceleration of the system would seem likely, accompanying the change in direction or alternatively in connection with the substitution of a second funnel for the first. This furnishes a possible explanation for the recurrence of circularity, but does not necessarily account for the sharp demarcation between damaged and undamaged forest noted in figure 7. The latter suggests the funnel was more in the nature of a spinning column of air, perhaps in solid rotation, moving through a relatively undisturbed environment not partaking of the tornado circulation. It is possible that this particular vortex was indeed dying out, as suggested previously, and was merely "coasting," separated from the VR circulation which was then attached

The final stage of the storm's course, as illustrated in figure 8, seems to differ substantially from the earlier patterns, and is most closely approximated by the three-way combination of rotation, translation, and inflow of model (*c*). This model appears to explain the flow from the southwest along the bottom of the path separated quite sharply from the flow from the north along the upper portion. A number of observers in this portion of the storm path reported marked wind shifts as the storm approached closely. At first, winds were from an easterly direction, with enough force to blow over smaller trees. A few seconds later the main storm struck with winds from a southwesterly direction, and with much greater force. Such a sequence would not be compatible with

FIGURE 10.—Hypothetical models of wind structure: (a) vortex + translation, (b) sink + translation, and (c) vortex + sink + translation.

model (a), but might very well occur with models (b) and (c) near the axis of motion, provided the final inflow speeds greatly exceeded the translational and rotational speeds. Thus, due to the high rate of inflow, the wind would blow back toward the approaching center for a brief period before the center passed, to be followed, south of the center, by strong flow in the direction of general storm movement.
